Manhole Inspection Summary

Manhole # S43CC_010MH

Location Address: **side of 1715 eager st**

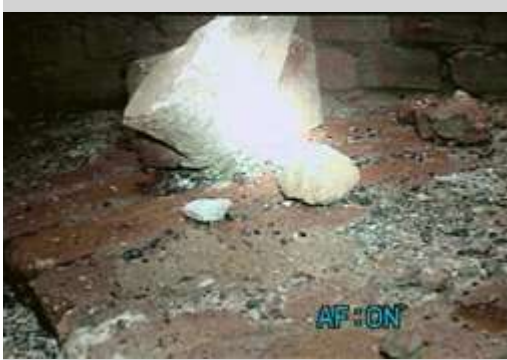
Condition: ☐ Sound ☒ **Cracked** ☐ Root Intrusion ☐ Loose Brick ☒ **Deteriorated**

chimney cracked and deteriorated

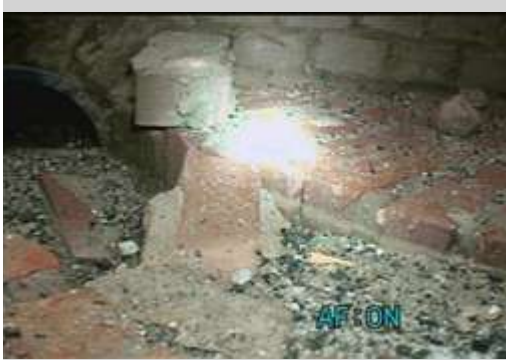
Defect 4

Condition: ☒ Sound ☐ Cracked ☐ Root Intrusion ☐ Deteriorated ☐ Leaks ☐ Debris

bench debris

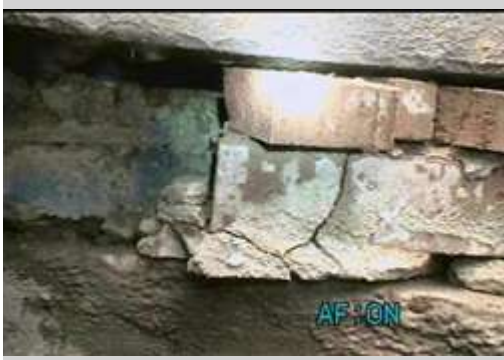
Defect 1

Frame Offset: **6** (in.) Condition: ☒ Sound ☐ Cracked ☐ Leaks

offset

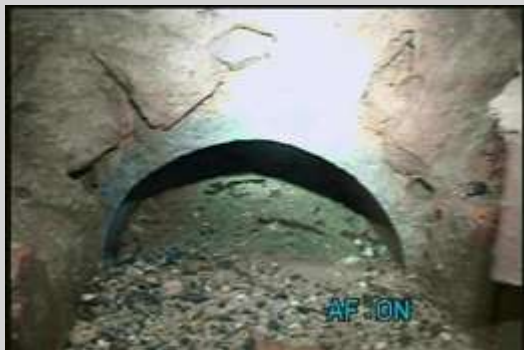
12 O'Clock Outflow

8 in. Circular Gravity Sewer
Pipe Out @ 12 O'Clock

Pipe Material: **Clay** ☐ Pipe Lined

Invert Depth: 9.00 (ft.) Flow Characteristics: **None**

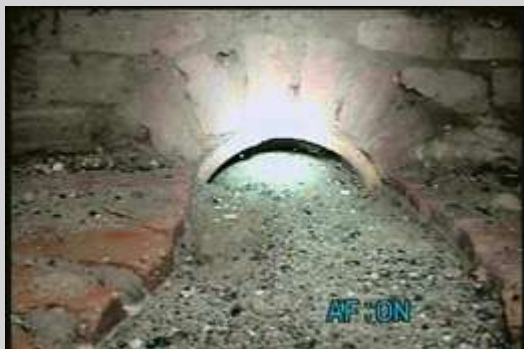
5 O'Clock Inflow

8 in. Circular Gravity Sewer
Pipe In @ 5 O'Clock

Pipe Material: **Concrete** ☐ Pipe Lined

Invert Depth: 8.92 (ft.) Flow Characteristics: **None**
